Assessment and repair of the bearing structure of a multi-storey parking garage

The construction of a multi-storey parking garage in Kikinda, Serbia started 20 years ago. The bearing structure was made of precast concrete columns, beams and ribbed floor slabs. After building of the bearing precast structure, the works were stopped and the unprotected structure was exposed to atmospheric influences (snow, rain, low temperatures). Many of the structure's elements were subsequently damaged due to insufficient concrete cover, badly performed reinforcement and incorrect manipulation of elements during erection. The initial defects and damage worsened to the extent that they not only severely affected the durability of the structure, but also jeopardised the stability and bearing capacity of some structural elements. Fissures and cracks, concrete spalling and reinforcement corrosion were registered on most of the structural elements. This paper presents the damage recorded, and the characteristic instances are illustrated by photographs. The results of subsequent testing of quality of built-in materials (concrete and reinforcement) are presented separately. To establish the actual condi

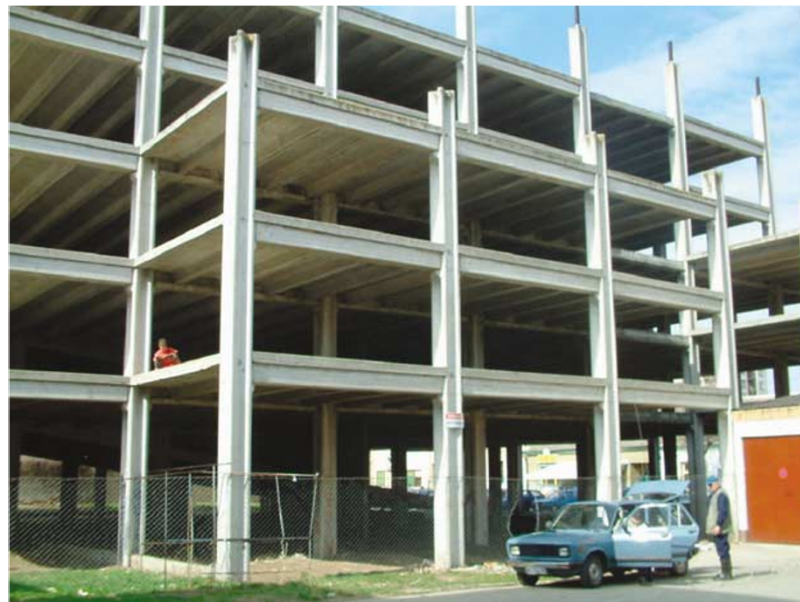
The structure of a multi-storey parking garage in Kikinda, Serbia was constructed during 1986–1987. After finishing the bearing structure, the construction works were stopped and the structure was left in an incomplete and unprotected condition (Figure 1).

Since the cessation of works on the structure, until recently, the bearing structure was exposed to atmospheric influences that caused various amounts of damage to different elements (fissures, cracks, concrete spalling and reinforcement corrosion, etc).

Figure 1: Appearance of the garage

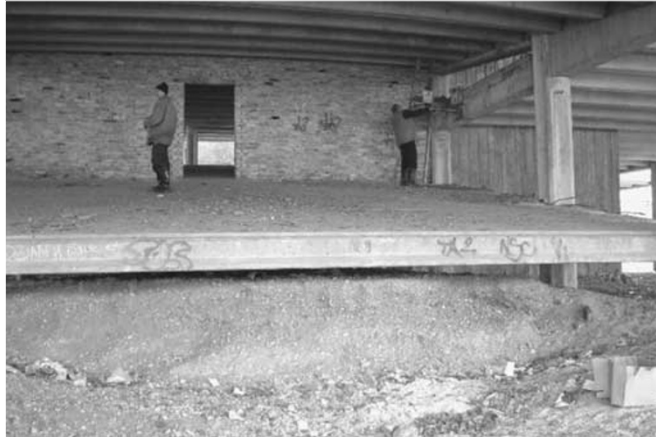
Figure 6: Uncompleted section of approach ramp

Several features on the structure were not completed, including the façade and the roof, the lower part of the approach ramp (Figure 6), the staircase and the entire finishing works (floors, fences, installations, etc). The monolithisation of floor structures was not entirely completed as well (concreting of ribbed parts between the Π -slabs, as well as the interconnection of Π -slabs and beams by *in situ* concreting layer over the beams) (Figure 7).

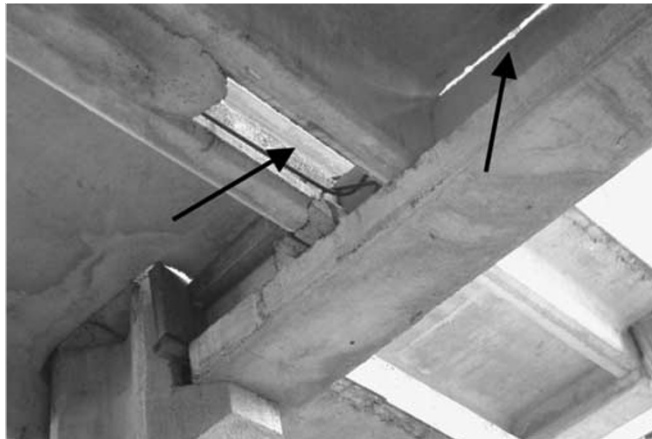
Figure 7: Uncompleted monolithisation of floor structure

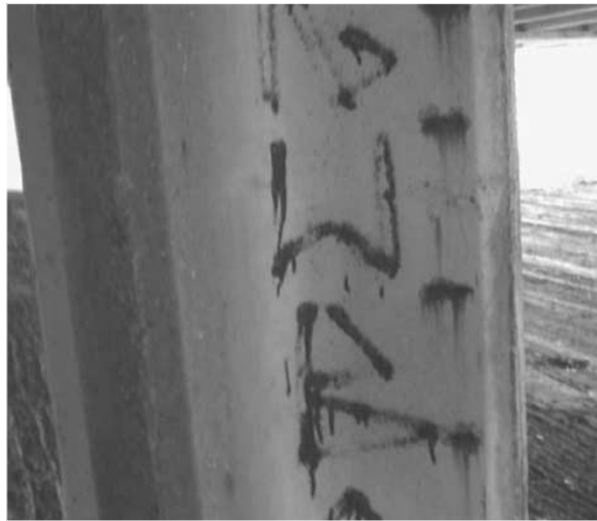
- *Insufficient width of the protective concrete cover* (Figure 8): This defect was registered on approximately 70 per cent of all columns.

Figure 8: Insufficient concrete cover and stirrups corrosion

- *Stirrup corrosion* (Figure 8): This damage is a local one, that is, there are ‘point’ traces of corrosion or ‘line’ traces of length up to 10 cm. The corrosion affected the stirrups on approximately 50 per cent of columns.
- *Longitudinal (vertical) cracks* induced by *corrosion of the main reinforcement* (Figures 9 and 10): These cracks are of width ≥ 0.3 mm and their length is generally larger than 1 m, and they were seen on approximately 50 per cent of the columns.
- *Porous (full of holes) concrete surface* (Figures 11 and 12): This was always registered on the same side of the columns due to the captured air during concreting.

The repair measures for cracked edges, corroded main reinforcement and stirrups in columns and beams consisted of:

- The removal of concrete up to the sound concrete, so as to free the main reinforcement and stirrups (Figure 39).
- Cleaning of visible parts of reinforcement from rust.
- Preparing of concrete surface (cleaning of dust and dilapidated concrete parts).
- Coating of the bared reinforcing rods with corrosion-inhibiting cementitious mortar.
- Applying of thixotropic fibre-reinforced mortar as a new concrete cover.

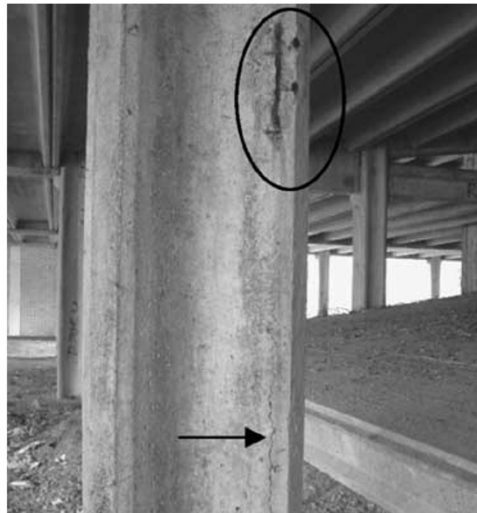
Figure 9: Corrosion of main reinforcement and longitudinal crack in column

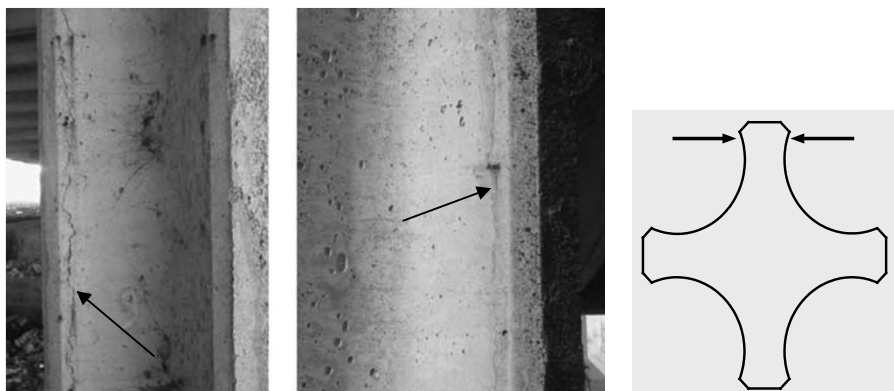
Figure 10: Longitudinal cracks due to corrosion of main reinforcement (registered always on the same corner of the columns due to the position of columns during concreting)

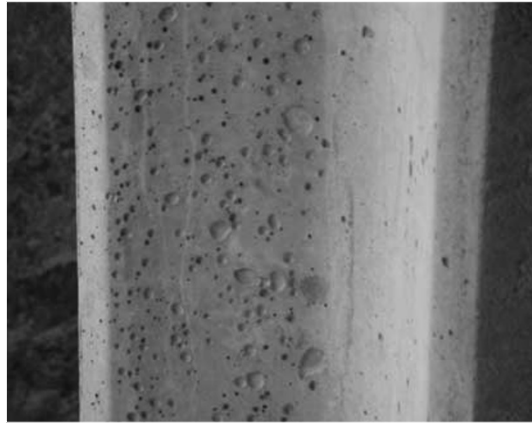
Figure 11: Porous (full of holes) concrete surface

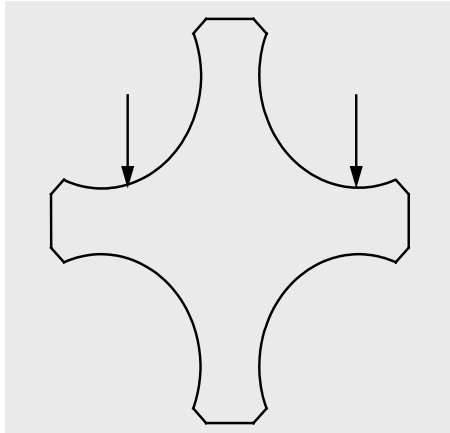
Figure 12: Side of the columns where the air was captured during concreting

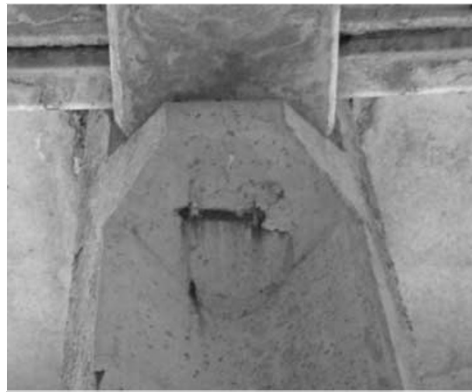
- *Insufficient thickness of the concrete cover* on the oblique front part of corbels (Figures 13 and 14) and

Figures 13: Insufficient concrete cover on column corbels

- *Separation and breaking-off of concrete pieces (Figure 15);*
- *Crushing of concrete;*
- *Corrosion of horizontal reinforcement — stirrups (Figures 13 and 14);*
- *Vertical and oblique cracks and fissures (Figure 17) where the width of cracks exceeds 2 mm.*

- In order to ensure the bearing capacity and stability of the construction, it is necessary to undertake some constructional repair measures in supporting zones of particular elements of the bearing structure (column corbels, supporting parts of beams and the supporting parts of ribs of Π slabs).

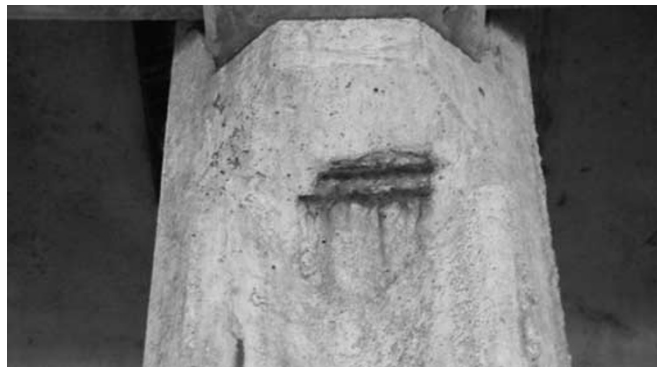
Figures 14: Insufficient concrete cover on column corbels

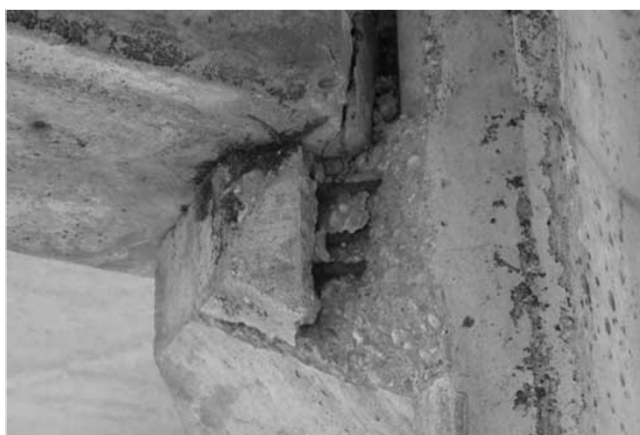
- *The protective concrete cover is far too thick on the vertical front part of column corbels due to the ‘incorrect’ reinforcement of column corbel (Figures 15 and 16).*

The above-mentioned damage was formed during assembly of the elements of the structure due to incorrect manipulation of these elements during placement into their projected position. The scale of this damage was increased due to the environmental effects of moisture and low temperature. This damage was registered in approximately 45 per cent of all column corbels.

Figures 15: Separation of cover from column corbels (thick cover and poor reinforcement arrangement)

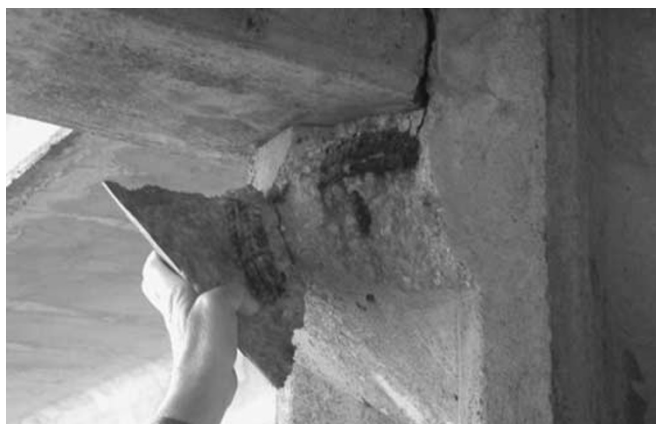
Figures 16: Separation of cover from column corbels (thick cover and poor reinforcement arrangement)

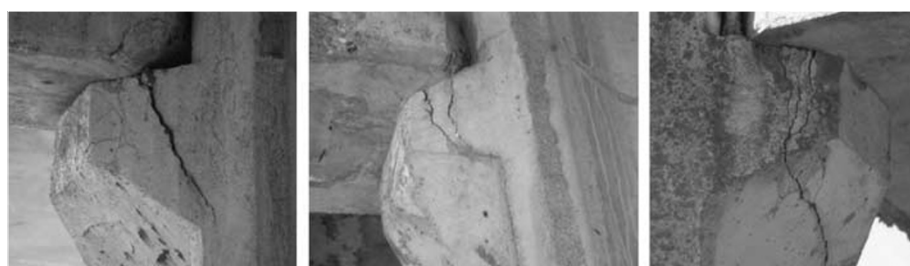
Figure 17: Oblique and vertical cracks

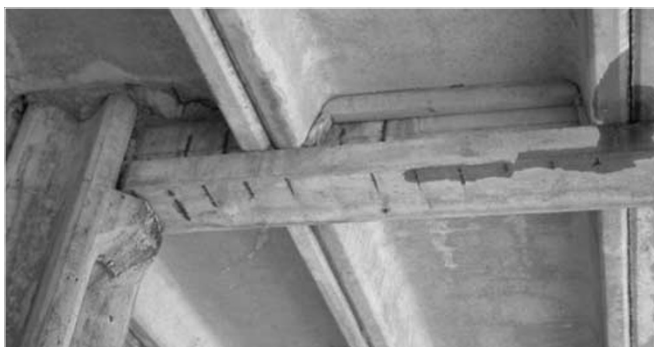
- *Insufficient thickness of the protective concrete covers (Figure 18) was registered on 65 per cent of the beams.*

Figure 18: Insufficient concrete cover and stirrups corrosion in the beam

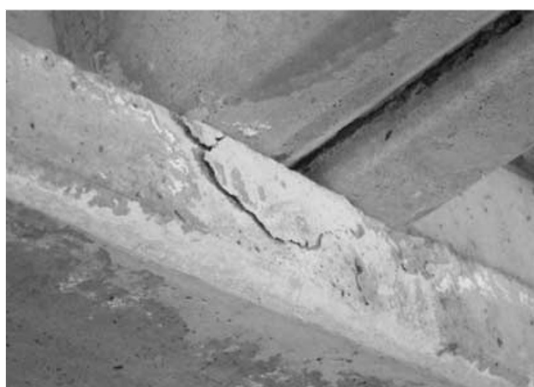
Figure 19: Local concrete crushing

- *Spalling of concrete* on spots was registered where the reinforcement corrosion is more stressed.
- *Vertical and oblique cracks and crushing of concrete* in the supporting zone of beams (Figure 15) was registered on 20 per cent of supports.
- *Local concrete crushing on the resting place of II slabs* (Figure 19) was registered on approximately 10 per cent of resting places.

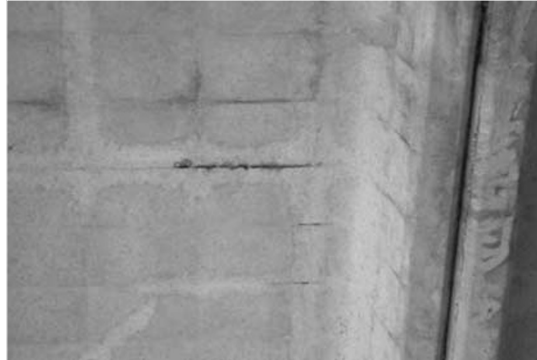
By visual examination it was registered that the insufficient thickness of concrete cover was the only defect of II slabs and, subsequently, the transverse reinforcement on the lower side of some slabs was visible (Figure 20). Besides the mentioned defect, the following damage was registered on the precast II slabs:

- *transverse fissures*, width ≤ 0.3 mm, mostly on the bottom side in the middle of the slab;
- *longitudinal fissures*, width ≤ 0.3 mm, mostly on the transition of the slab into the rib of the slab;
- *oblique cracks and fissures*, width up to 0.5 mm, in a supporting zone of the II slabs;
- corrosion of the transverse reinforcement;

Figure 20: Defects and damage of Π slabs

- To ensure the durability of bearing elements of the structure, it is necessary to undertake appropriate repair measures to protect the built-in reinforcement and concrete (by placing an additional protective concrete cover of required thickness and/or covering with appropriate protective coating). With these works, it is necessary to comprehend all the examined elements of the structure (columns, precast beams, reinforced concrete walls, Π slabs).

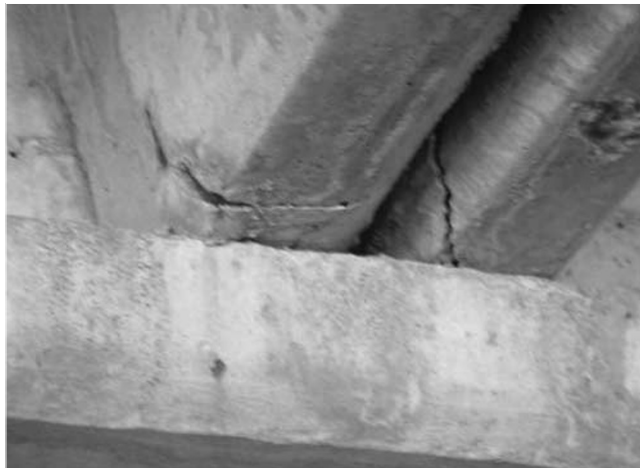
- *spalling of concrete* on the spots where the reinforcement corrosion is more stressed;
- *vertical and oblique cracks and local concrete crushing* on the resting places of ribs of the Π slab (Figures 21 and 22).

Figures 21: Vertical cracks in the resting places of ribs of the Π slab

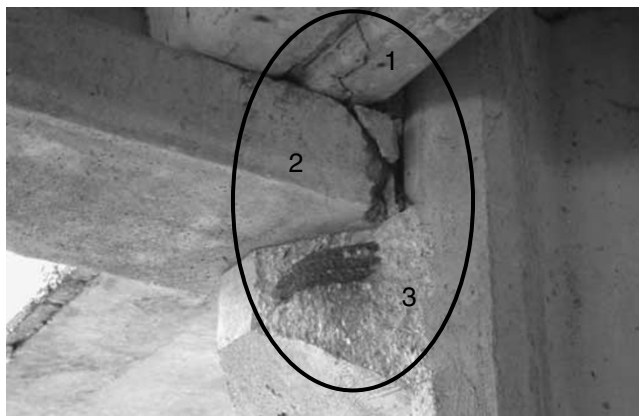
Figures 22: Oblique cracks in the resting places of ribs of the Π slab

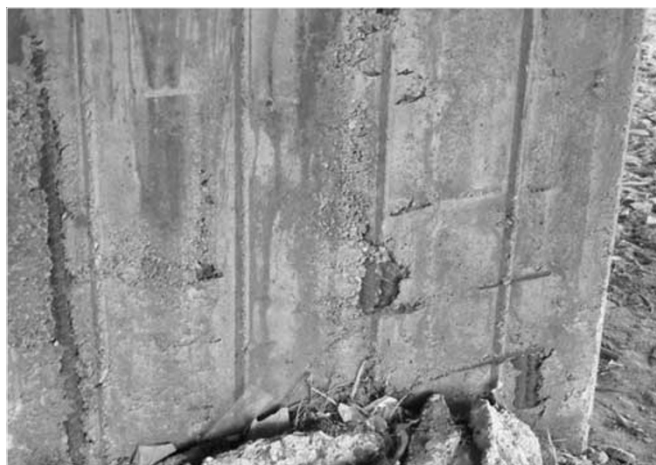
Figure 23: Defects in RC wall

By visual examination of reinforced concrete walls, the following defects were registered (Figure 23):

- uneven concrete surfaces;
- insufficient thickness of the protective concrete cover with visible reinforcement;
- concrete honeycombing and segregation zones.

- *vertical and oblique cracks and fissures* that mostly enclose the entire cross-section of the wall;
- corrosion of the reinforcement.

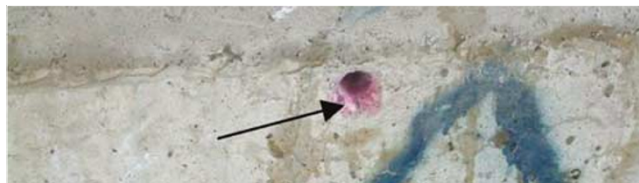
Figure 25: Measurement of carbonisation depth

To check the condition of protective concrete cover in respect of corrosive passivity of the reinforcement, the depth of carbonisation was examined using a colorimetric method using phenolphthalein (Figure 25). The tests were performed on 20 measuring spots, and it is concluded that the carbonisation process is not extended over the protective concrete cover.

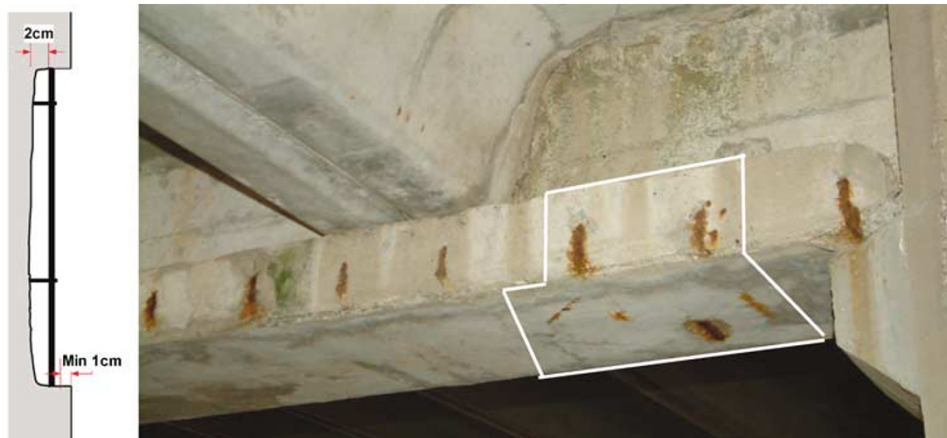
Figure 39: Forming of opening in concrete at the place of corroded rods
