Structural health monitoring of bridge structures in cold climates

Oğuzhan Çetindemir¹, Abdullah Can Zülfikar¹, and Ali Yeşilyurt¹

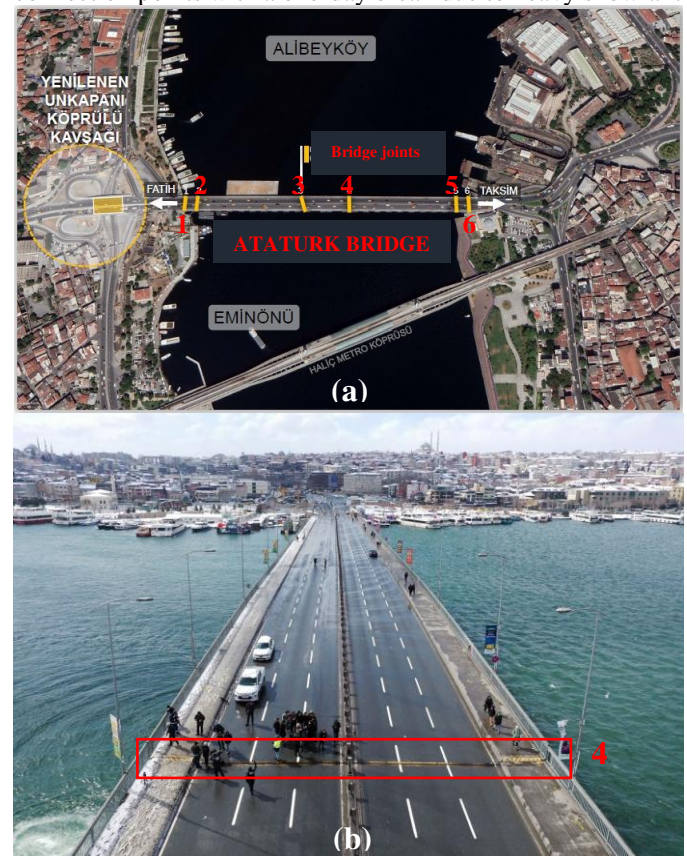
Figure 1. Atatürk Bridge (a) location (b) gap in the deck.

The Atatürk bridge, also known as the Unkapanı Bridge among local people, was opened in 1940 in Haliç Golden Horn and connecting two counties, Fatih and Beyoğlu (Taksim) in İstanbul, Turkey. It is 453.5 meters long and 25 meters wide. The historical Unkapanı Bridge was positioned on 24 pontoons and two side abutments in its construction. The maintenance and repair of 21 pontoons, except for three with good structural conditions, were just carried out in the past years. The Unkapanı (Atatürk) Bridge is a drawbridge and is scheduled to be opened to marine traffic once a week in summer and twice a week in winter, thereby closed to vehicles and pedestrian traffic during such period. The location of six bridge joints is shown in Fig. 1a. A very recent incident during the snowstorm on 11-13th March 2022 in İstanbul was observed three times in a row. The bridge was split into two, causing a gap of about 20 cm at the bridge's 4th connection points (Fig. 1). Right after the event, there were many questions about whether there was an engineer's fault on the Unkapanı Bridge, separated from the connection points with a one-day break due to heavy snowfall.

It was stated by Istanbul Metropolitan Municipality (IMM) that it was not the engineers' fault that caused the separation on the Unkapanı Bridge. While it is said that the bridge was built on pontoons and designed not to prevent the passage of ships, it was officially announced that the drawbridge was divided into two depending on the weather conditions (Fig. 2). As it was stated that the maintenance of the Unkapanı Bridge was carried out recently, it was underlined that the historic bridge has been standing for 82 years.

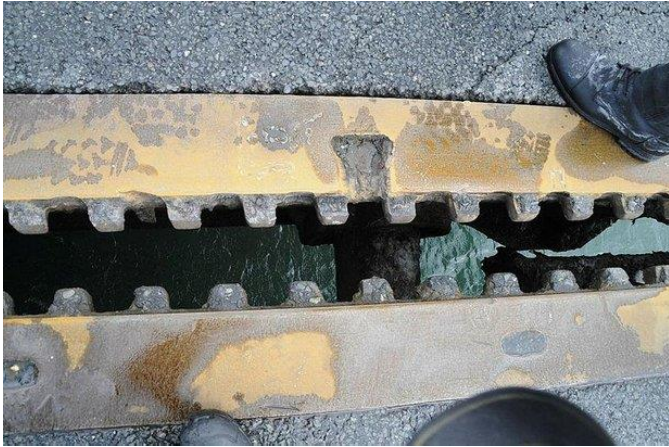
Figure 2. A closeup view of gap at the connection in deck.

According to examinations, the structural conditions of the steel carriers are satisfactory, but they cannot perform their functions due to the time-dependent deformation of the movable expansion joints at the two ends of the bridge and the tension system that allows the bridge to move on the rails. Therefore, severe maintenance and repair projects are being prepared. Although the functional defects detected in the bridge's expansion joints do not pose a significant problem regarding the bridge's structural safety, the project teams continue to determine and project for maintenance and repair.

The services related to the maintenance and repair of the bridge are as follows: (1) connection joints from the upper part of the bridge, dilatations, jack bearings, guardrails, steel barriers, repair of the pontoons at the bottom of the bridge when they are punctured, mechanical locking system, chain tensioning system of the bridge, casting and controls of the bridge anchors (vault), steel constructions, horizontal axis movement control and maintenance of rollers and bearings, (2) electrical installation maintenance and repairs [17].

Due to the opening in the Unkapanı bridge joints, Şiřhane - Fatih direction was closed entirely to traffic. After placing pontoons on the bridge roads in the Fatih - Şiřhane direction, the traffic will be provided in a single lane in the Şiřhane - Fatih direction [18]. After two hours of closure, the Unkapanı Bridge was opened to traffic by applying tensioning process on the chains [19]. As a result of the examinations, it was stated that the inspection is continuing to ensure that the traffic can be processed safely on the Unkapanı Bridge, which is divided into two from the connection points three times. It was stated that the IMM Maritime Services Directorate carried out the operation and routine maintenance of the historic bridge and that the teams instantly followed the mechanisms of the bridge and intervened when necessary.
