INDUSTRIAL APPLICATION

Wireless Monitoring of a Multispan Bridge Superstructure for Diagnostic Load Testing and System Identification

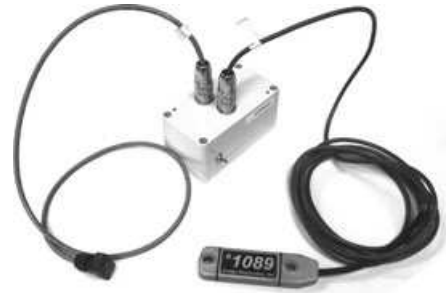
Fig. 1. Wireless sensor system (WSS) node with accelerometer and strain transducer.

The WSS developed within the Laboratory for Intelligent Infrastructure and Transportation Technologies (LIITT) at Clarkson University was designed as a universal platform for high-rate, large-scale monitoring of the structural response (Figure 1). The sensor network is composed of an array of distributed sensing nodes that interface with sensors (i.e., accelerometers, strain transducers, temperature sensors), condition the analog signals, then convert them to digital readings, and transmit the data to a base coordinator. The base coordinator features the same wireless transceiver hardware as the remote nodes; however, its embedded functionality is to control high-rate, bi-directional wireless communications between the host computer and the distributed sensing units. The base coordinator is connected to the host computer across a universal serial bus (USB) connection using the communications device class to present the interface as a virtual COM port. This physical hardware interface is advantageous as it enables either network control from a CPU local to the measurement site or remote access across an internet connection through TCP/IP protocol using a

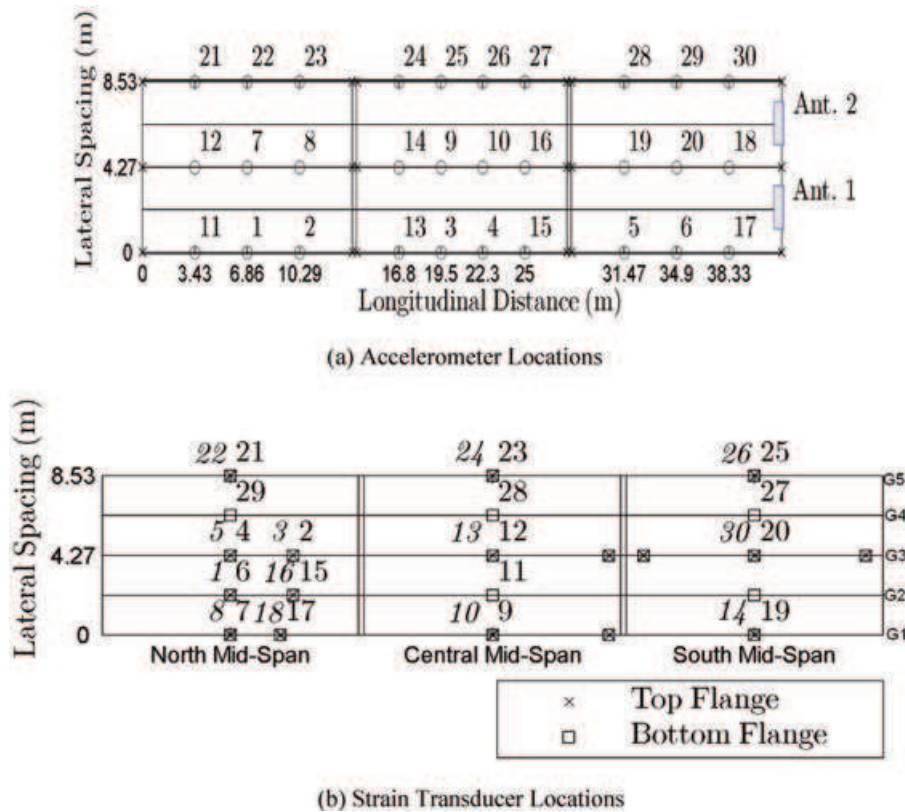
Fig. 3. Instrumentation layout for testing performed at the RT345 Bridge site.

The bridge was instrumented at 30 locations over the three spans with dual-axis accelerometers for a total of 60 vibration measurement axes (Figure 3a). The use of a large number of stationary accelerometers enables simultaneous collection of vibration time histories across the structure. This is advantageous to using a roving system with reference accelerometers as it ensures consistent temperature, ambient vibration spectral characteristics, and consistent traffic loading. Furthermore, a stationary array would be necessary for permanent installation, so the deployment validates the ability of the network to deliver the required bandwidth for a long-term network infrastructure. Sampling durations of three minutes were collected in real-time of the digitally filtered analog to digital converter (ADC) conversions measured at 512 samples per second (Sps) and downsampled to a per channel rate of 128 Sps for transmission. An oversampling approach is implemented within the embedded software during the acquisition of measurements from the 12-bit ADC to increase the effective resolution of the conversion as well as to virtually eliminate signal attenuation in the measured bandwidth. Sensor data are oversampled and then passed through a digital low-pass filter prior to downsampling to the desired effective data rate that is transmitted across the radio. The digital filter is a 56th-order equiripple design implemented by the embedded software with the microcontroller hardware multiplier (Whelan and Janoyan, 2009). The use of oversampling reduces the effect of ADC quantization noise and is generally accepted to provide an additional bit of effective resolution for each power of four rate of oversampling.

As part of the original load test, strain transducers were placed at alternative locations of the north span away from the midspan along girders 1–3 (sensors 2, 3, 15, 16, 17, 18 in Figure 3b). These locations were selected based on visual differences in deterioration which may account for a varying response to the midspan measurement. The primary purpose of these measurements was to determine if the NA differed between the alternate sections and the midspan locations. Table 1 presents the results where “alternate” refers to the monitored location away from the midspan (i.e., sensors 2, 3, 15, 16, 17, 18 in Figure 3b). The results indicate a strong discrepancy among the findings at the midspan and alternate monitoring locations of girders 2 and 3. As the NA location appears to be much higher at the alternate locations, there is a possibility that the deterioration of the steel girder has caused the NA to shift toward the stiffer deck element. Alternatively, girder 1 shows a slightly better similarity between the two locations. Upon visual inspection, girder 1 appeared to possess the greatest uniformity in condition among girders 1–3 in the north span. Additionally, girders 1 and 5 show a higher NA compared to the remaining girders

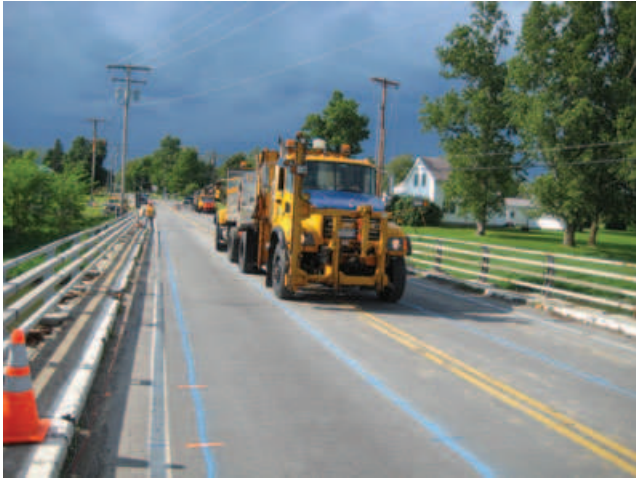
Fig. 9. Two test vehicles in the center lane during load testing.

and b from the truck leaving the north span to enter the center span. Twenty-three wireless and one wired sensor at the midspan (bottom flange of G2 on the south span) were employed for determining various section properties and demand parameters within the structure. A total of seven static (stationary) load tests were conducted using a combination of two H trucks (weighing 21.74 metric tons each) in three separate loading lanes. Initially, the entire structure is in an unloaded state. After a brief few seconds with zero strain on the bridge, the test vehicle(s) drive south along the bridge stopping for a period of approximately 20–30 seconds at the midspan of each of the three spans. In the case of one test vehicle in a particular loading lane, the rear axle is positioned at the midspan of the particular span (Figures 7a–d). When two vehicles are used in one loading lane (Figures 7e–g), the rear axles are positioned approximately 1.5 m (5 ft) on both sides of the midspan. This is the distance between the rear axle and the back of the dumper on the truck, allowing for tighter vehicle configuration within the lane. Figures 7 and 8 display the position of the test vehicles for each of the seven tests performed on each span. Figure 9 is a photo of two trucks positioned on the center lane during the load test.

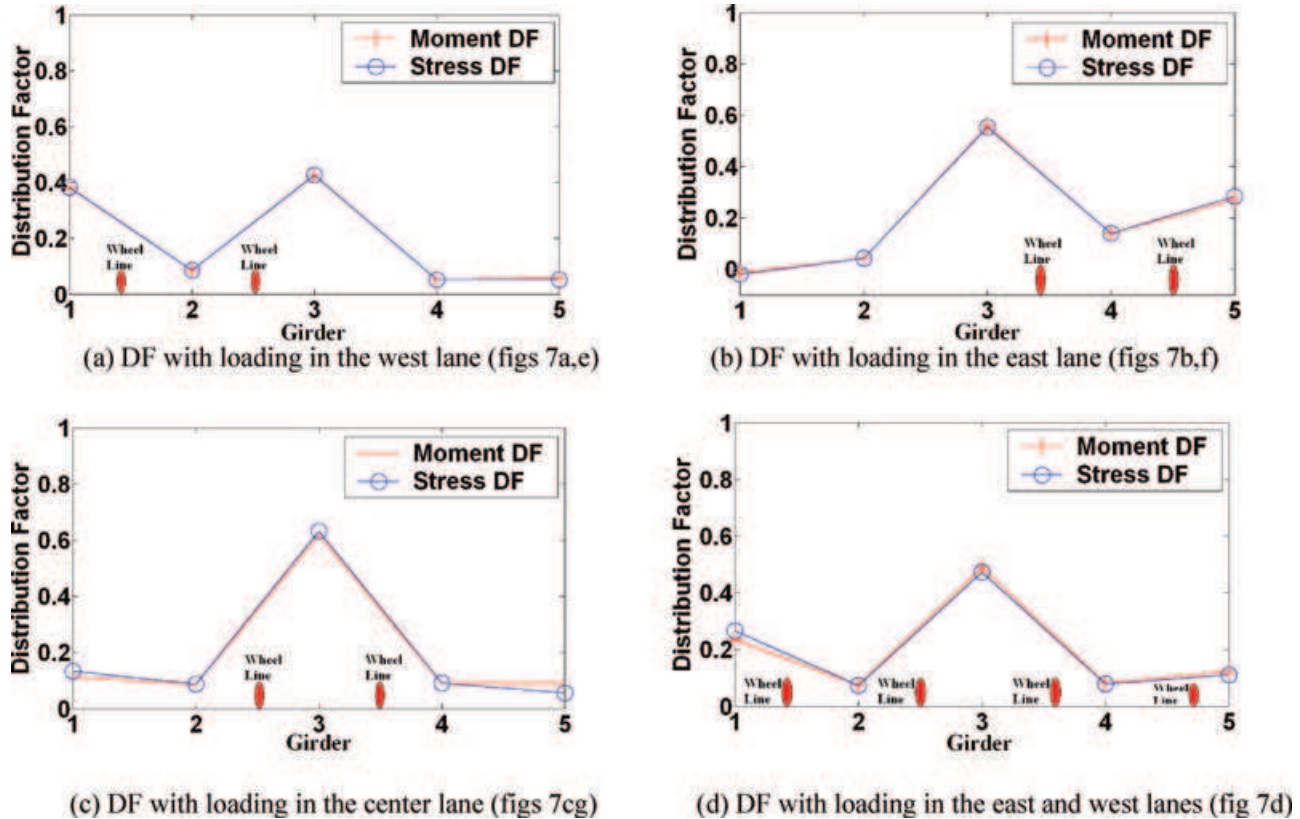
Fig. 11. Distribution factors (DF) for the center span.

Although one would not expect the stress and moment-based DF values to exactly match due to differing section moduli, the trends and relative closeness should be apparent. The north span displayed some discrepancy among the two methods which is much less apparent for the center span as seen in Figure 11. In the first two cases (Figures 11a and b) there is very little if any significant difference. There are however some anomalies present within the various distributions that were not expected. Loading in either the east or west lane (Figures 11a and b) shows a higher distribution of the loading to the center girder as opposed to the girder where the load is concentrated. Girders 1 and 5 are not demanding a high concentration of the load when the truck is in the east and west lanes respectively. The presence of the curb and deck overhang typically results in a stiffer section than an interior girder and therefore has a greater load demand. This result could suggest some internal damage to the structure in transferring the loading to selected members. It is evident from the loading locations that girders 2 and 4 are not demanding the load that one would expect. This could be the result of poor sensor readings or damage within the bridge elements which in turn alters the results for the remaining girders. A maximum distribution of approximately 62% is observed when loading occurs in the center lane. Although testing in the north span did not show any mirrored responses from the east lane and west lane load cases, there appears to be a much closer response here.

Figures 10–12 display different behaviors based on identical loading conditions of three very similarly designed spans. The existence of damage or change in section properties within each of the spans likely explains the difference in results. One such example of this damage is the presence of a restraint bearing of girder 3 in the center span; this is clearly depicted from the strain time history in Figure 6c. Ideally, an expansion bearing would allow for free rotation and longitudinal translation. However, the presence of negative strain in the bottom flange indicates rotational restraint exists. In fact, the most recent biennial inspection report noted overextended bearings and that “corrosion on the rocker bearing interface and upper socket assembly restrict its free movement,” thereby suggesting the presence of significant, and most probably nonuniform, fixity at malfunctioning bearings. An example of a pinned bearing with significant corrosion on the northern pier for girder 5 is shown in Figure 13. Furthermore, according to tilt sketches taken at -1°C and subsequently at 28°C , the bearing inspected in the routine was found to experience virtually no movement despite the large temperature differential implying a fixed condition caused by corrosion and packing. A nonuniform change in bearing restraint across the different girders is a probable cause of the unanticipated differing responses recorded. These results suggest that the response of the as-built structure has changed as identical loading cases on nearly identical span layouts in a healthy structure should produce a similar behavior. Unlike in the case of the NA locations, the resolution and quantization of the noise of the strain measurement did not play as significant a role in the DF result. This

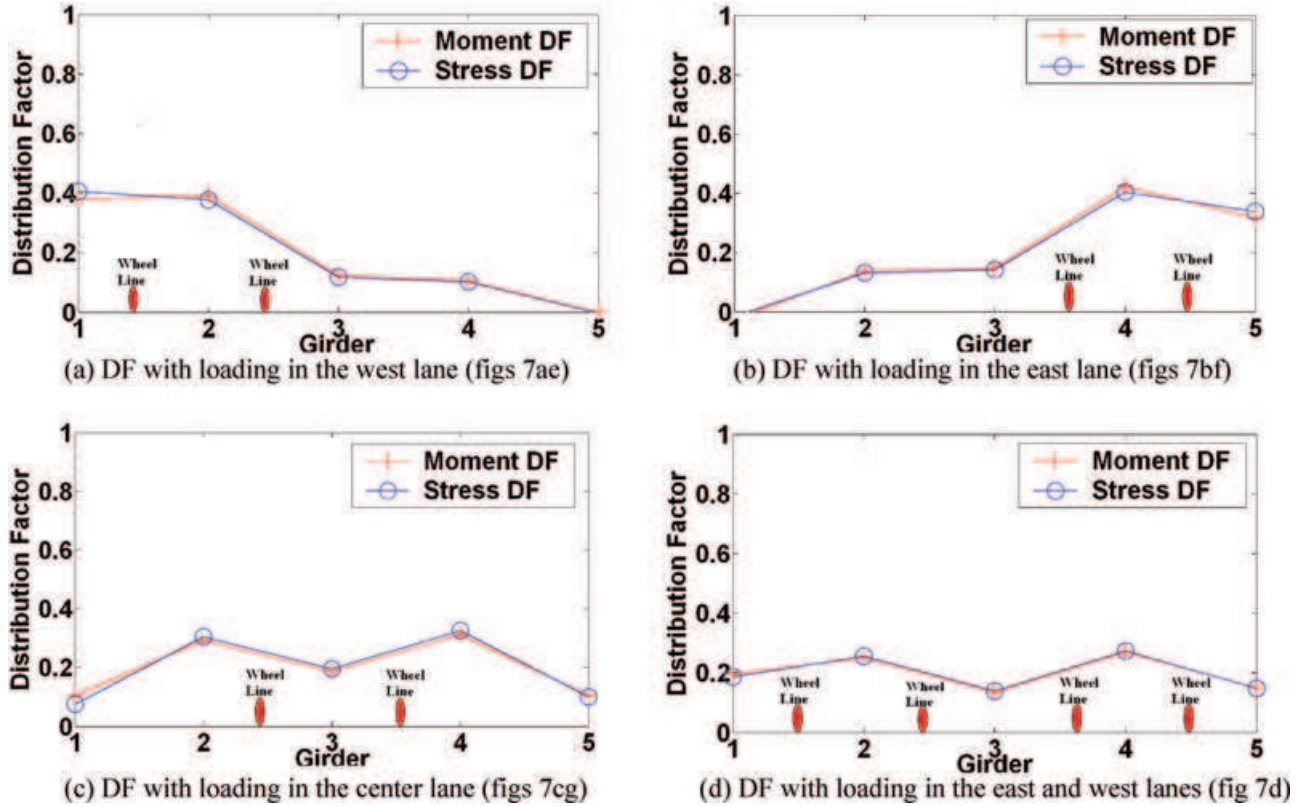
Fig. 12. Distribution factors (DF) for the south span.

The south span showed distinctly differing results from the other two spans. The load case corresponding to loading in the east lane (Figure 12b), shows the primary load carrying member to be the girder which the truck is directly over (girder 4). A near reflective pattern is seen with loading in the west lane over girder 2. It is interesting to note that the distribution of the loading to girder 3 in Figures 12c and d is lower than that of girders 2 and 4 when the load is directly atop of girder 3. Both results could suggest that the stiffness of the center girder is not as great as the remaining two interior girders. A comparison between the stress-based and moment-based DF values appear to correlate strongly, similar to that of the center span. In comparison to the remaining two spans, only loading in the east lane (Figure 12b) is similar to identical load case in the center span (Figure 11b).

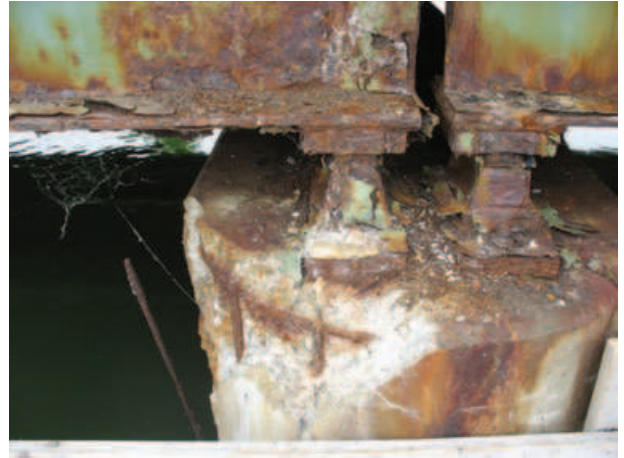
Fig. 13. Corroded bearings at the northern-most pier of the bridge.
