Assessment and repair of the bearing structure of a multi-storey parking garage

The construction of a multi-storey parking garage in Kikinda, Serbia started 20 years ago. The bearing structure was made of precast concrete columns, beams and ribbed floor slabs. After building of the bearing precast structure, the works were stopped and the unprotected structure was exposed to atmospheric influences (snow, rain, low temperatures). Many of the structure's elements were subsequently damaged due to insufficient concrete cover, badly performed reinforcement and incorrect manipulation of elements during erection. The initial defects and damage worsened to the extent that they not only severely affected the durability of the structure, but also jeopardised the stability and bearing capacity of some structural elements. Fissures and cracks, concrete spalling and reinforcement corrosion were registered on most of the structural elements. This paper presents the damage recorded, and the characteristic instances are illustrated by photographs. The results of subsequent testing of quality of built-in materials (concrete and reinforcement) are presented separately. To establish the actual condi

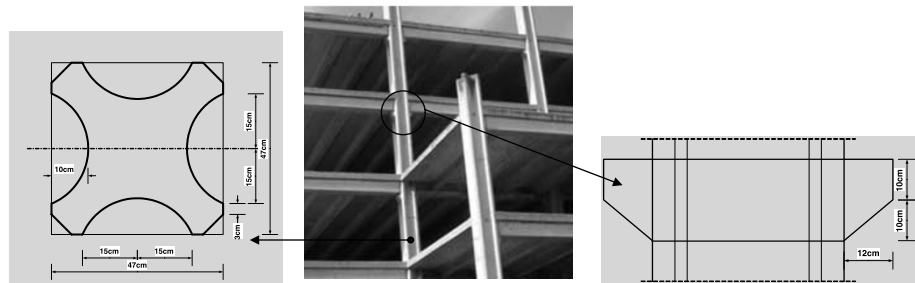
Figure 3: Reinforced concrete columns and corbels

- *Reinforced concrete columns* of X cross-section and external dimensions of 47×47 cm (Figure 3). The columns are precast of concrete class (CC) 50, designed in one piece and of different heights (3, 4 or 6 stories). The columns are reinforced with ribbed bars of RA 400/500. On all the reinforced concrete columns on which the beams rest, *short cantilever elements* (corbels) were implemented;

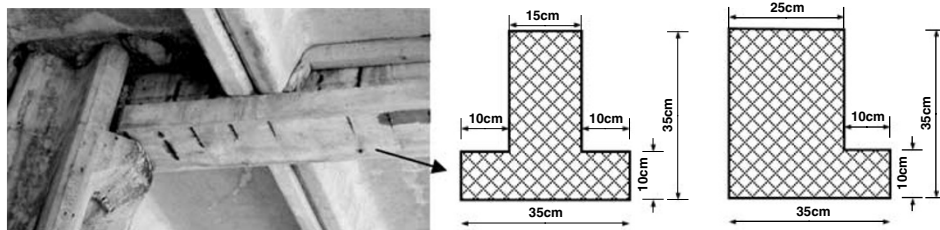
Figure 4: Prestressed reinforced concrete beams with 'I' or 'L' cross-section

- *The longitudinal beams* are prestressed reinforced concrete beams, with a span of 4.5 m or 5.1 m and of ‘L’ or ‘⊥’ cross-section (Figure 4). Dimensions of the beams in their cross-section are 35×35 cm. Cables of 7Ø5 mm for the adhesive prestressing, and ribbed reinforcement RA 400/500 were used. With the basic building plan of the structure, an additional protection from the torsion of longitudinal tail beams was provided by their connection to the columns and additional concreting of the joint between the beams and columns.

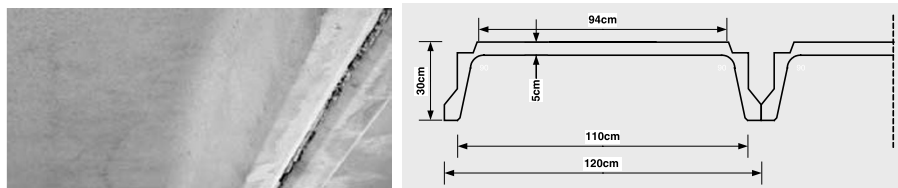
Figure 5: Prestressed ribbed floor slabs

- The II floor slabs (ribbed floor slabs) have a width of 120 cm, a height of 30 cm, a slab thickness of 5 cm and are of different lengths of 4.8, 5.4, 10.4 and 9.8 m (ramp). The II slabs were adhesively prestressed (cables of 7Ø5 and 3Ø3 mm were used). The joint between the adjacent II slabs was monolithed on location with concrete (Figure 5).

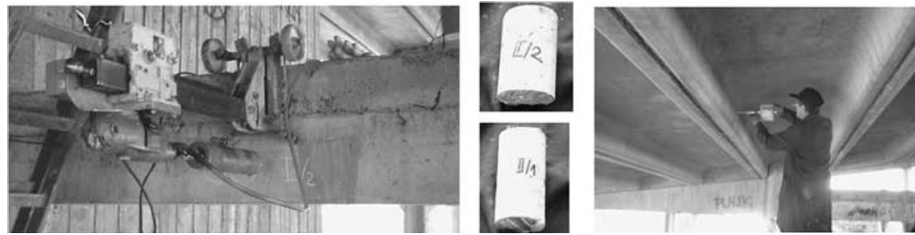
Figure 24: Testing of concrete quality

Subsequent determination of compressive strength of the concrete was performed with a combined method by extraction of concrete cylinders from the elements of the structure (21 cylinders) and by determination of the surface hardness of concrete with a Schmidt hammer (Figure 24) (Folić and Radonjanin, 1993). This combined approach was applied as extracting cores of required dimensions from the columns and the Π slabs was not possible. Compressive strength of concrete calculated at age of 28 days, obtained by cores, is shown in Table 1, which identified that in all the examined elements the projected CC was achieved.

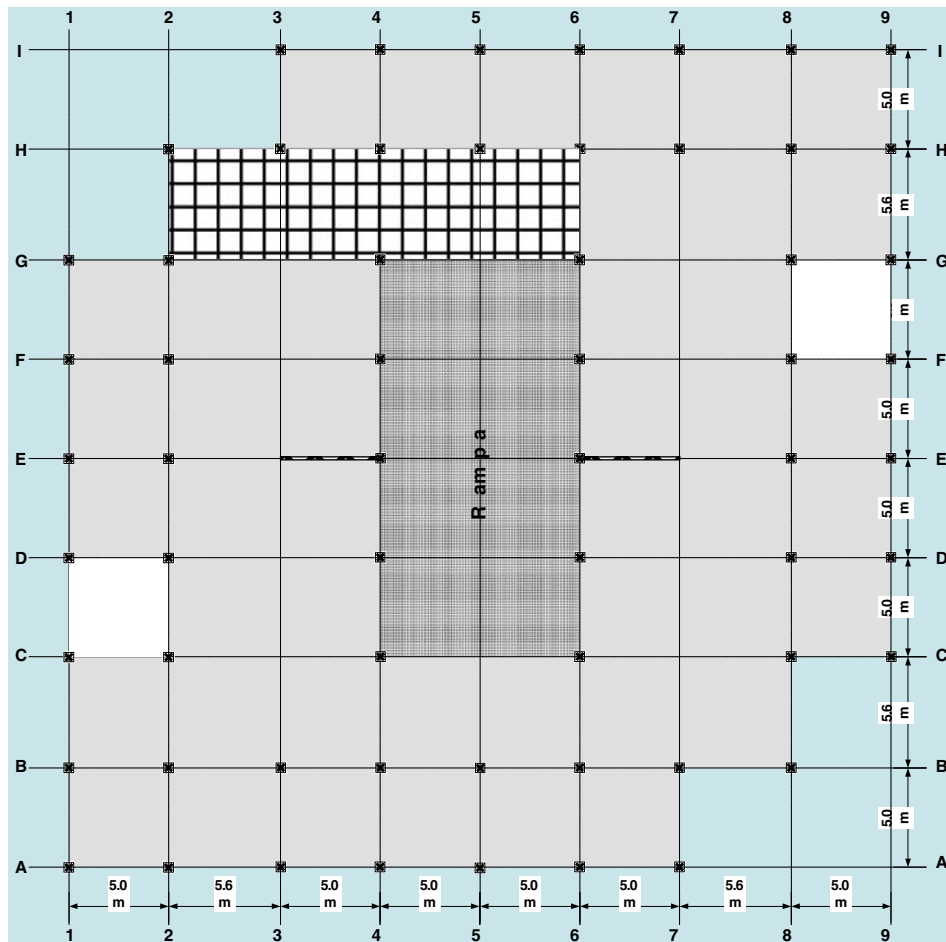
Figure 26: Load testing area

To establish the actual condition of the bearing structure of the garage, an examination was done by load testing (Radonjanin and Malešev, 1997). The testing load that corresponds with the operational conditions was applied in the field between axis G-H and 2-6 (Figure 26).

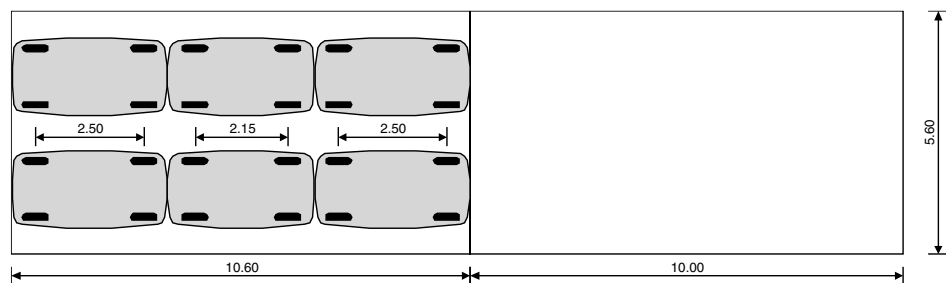
Figure 27: Position of loading phase 'A'

Loading was performed in two phases. In phase 'A', six cars were used as a test load (Figures 27 and 28), and in phase 'B' 12 cars were used (Figures 29 and 30). For numeric modelling of the structure under test load, a finite element method was applied. Measurement of stresses and deflections was done with strain gauges and mechanical comparators. A deformer was used as a control device for measurement of stresses. Arrangement of measuring devices is shown in Figures 31 and 32.

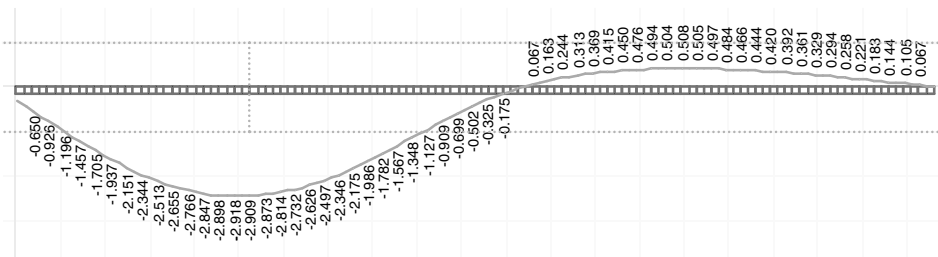
Figure 33: Deflections in longitudinal direction in loading phase 'A'

Calculated values for the deflection of the precast Π slab in loading phase 'A' are shown for longitudinal direction in Figure 33 and in Figure 34 for transversal direction. Deflections of precast Π slabs in loading phase 'B' are shown in Figures 35 and 36.

By comparison of the obtained test results with the designed values, it was concluded that the behaviour of the structure under load testing is normal (measured deflections are smaller than calculated ones, and residual deflections are in allowed limits).
